Refurbishment of Failed Flat Roofs

**Maximise your Investment with the
Right Waterproofing Solution**

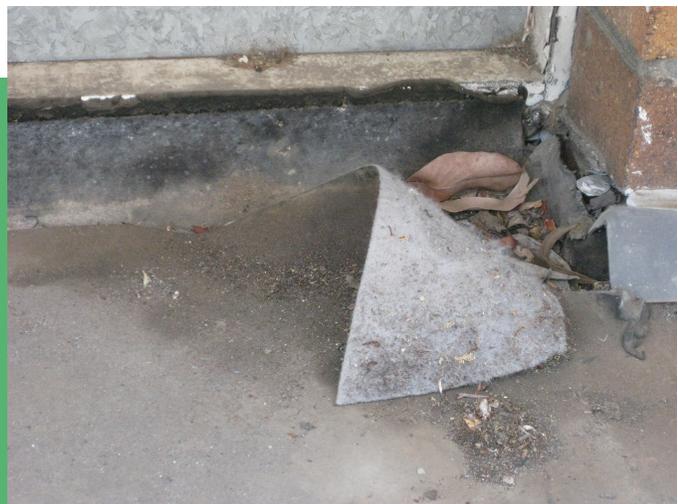
1. **Poor Perimeter Detailing/ Failure at upturn.**

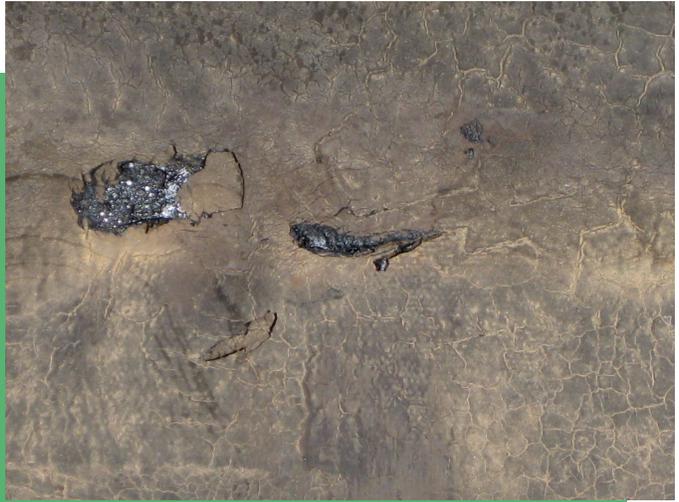
**Failure of
the
outermost
weathering
layer.**

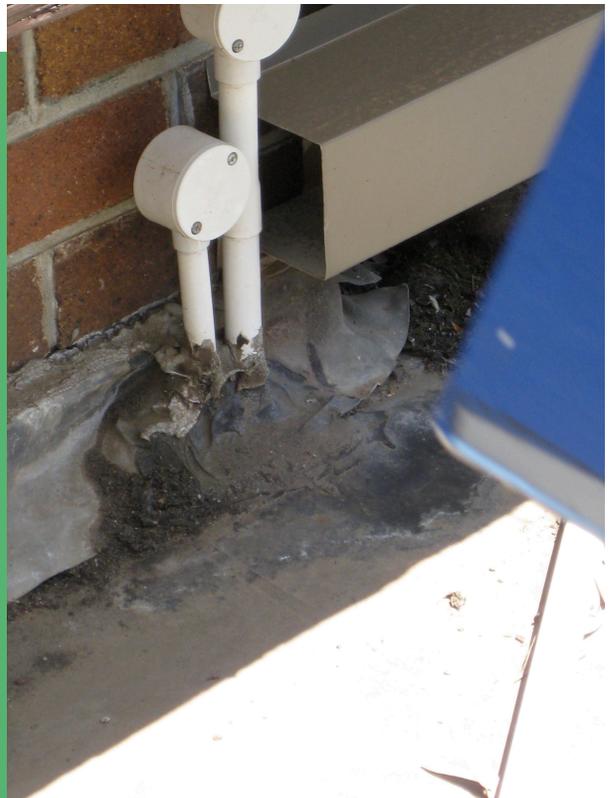
**Inadequate
& Poor
Detailing
around
Penetrations**

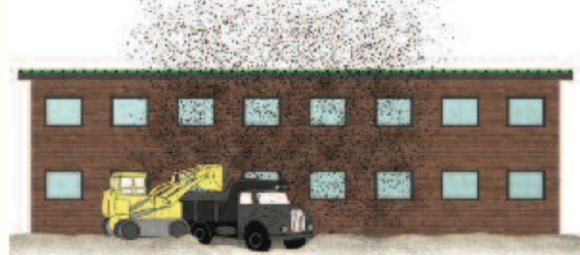
- Emissions from power stations, steelworks, cars and factory chimneys do not harm WOLFIN membranes.

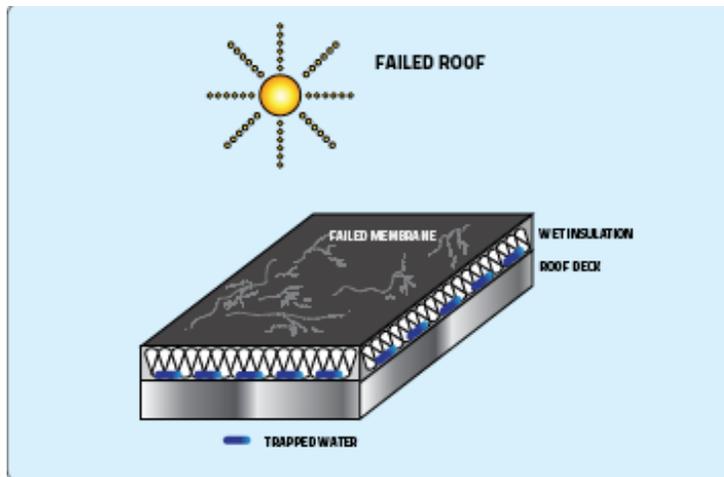
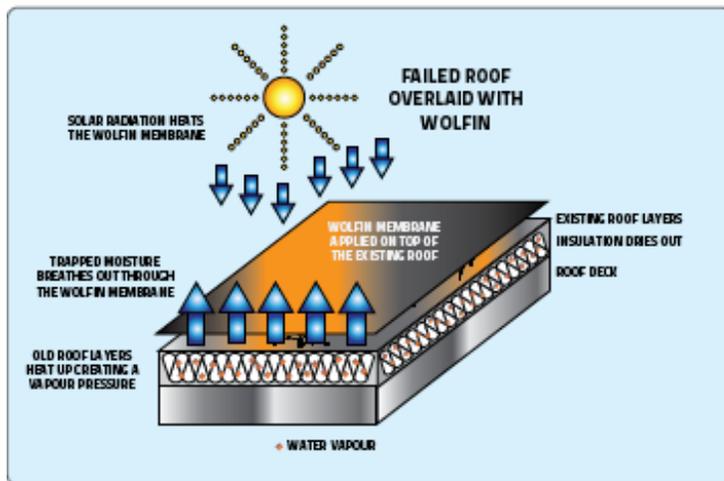
In most cases the old membrane is retained & the new Wolfin Membrane is installed directly over the existing failed membrane (including bitumen)

Of all the Thermoplastic roofing & waterproofing membranes in the market, WOLFIN offers the highest water vapour diffusion permeability, which allows the trapped moisture in the roof layers to completely dry out.
